Hikitia

Conservation Plan

CONSERVATION PLAN

Prepared by Michael Kelly, Heritage Consultant

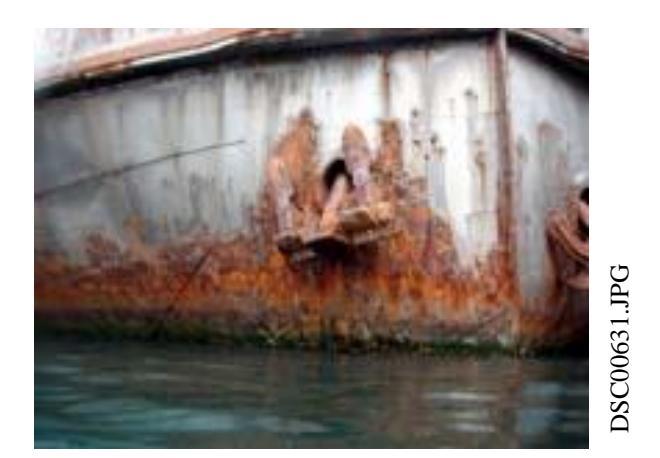
Picture DSC00631 shows the level of corrosion on the starboard bow increasing nearer the water line. This is fairly consistent around the vessel, though is more apparent on the starboard side because of its exposure to harbour wave action.

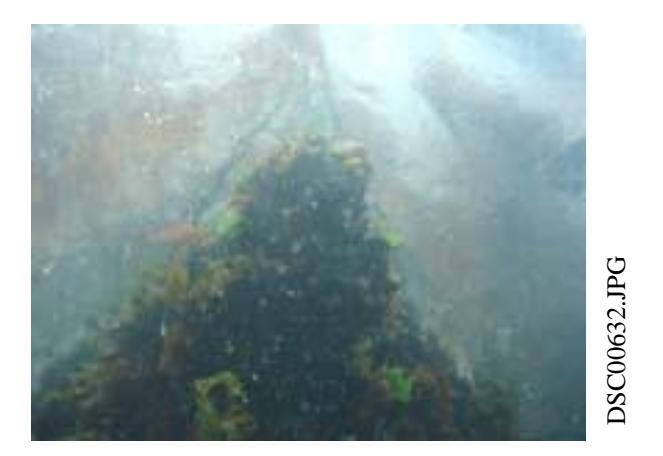
Picture DSC00632 shows the marine growth just below waterline on the bow. It consists of a thick encrustation of shellfish (approximately 100 mm thick) with red and green seaweeds.

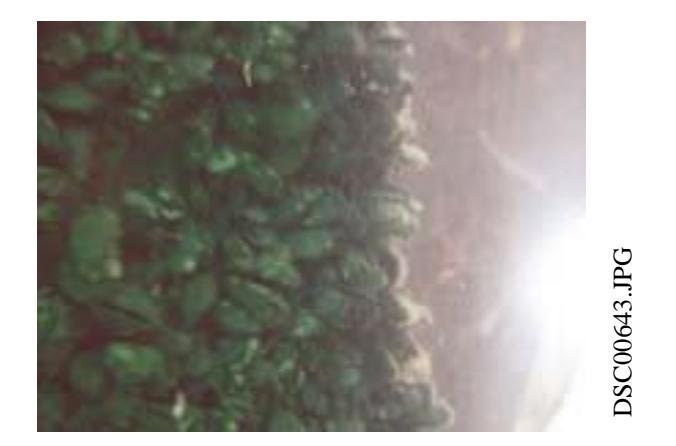
Picture DSC00643 is taken about 2 metres below waterline on the port side. Because of the low light levels on this side there is virtually no weed growth until very shallow depths, though there is still a thick encrustation of shellfish.

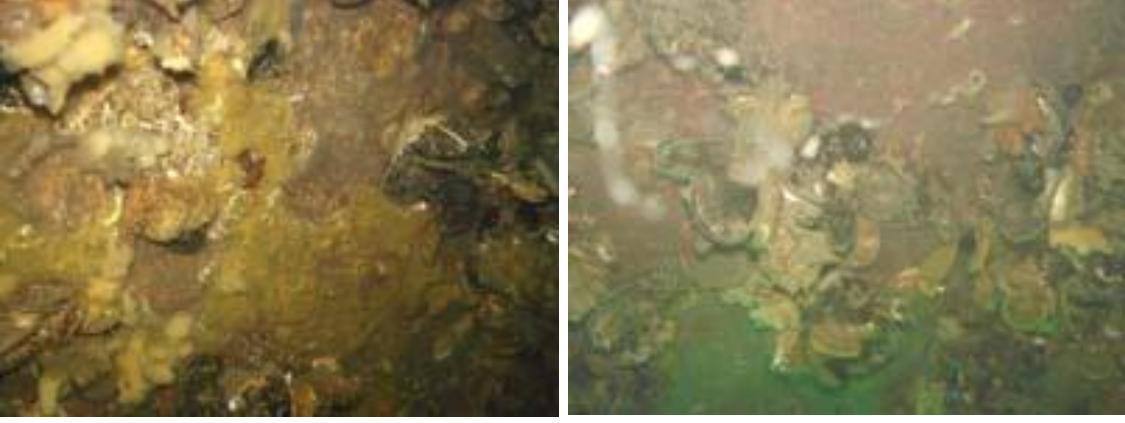
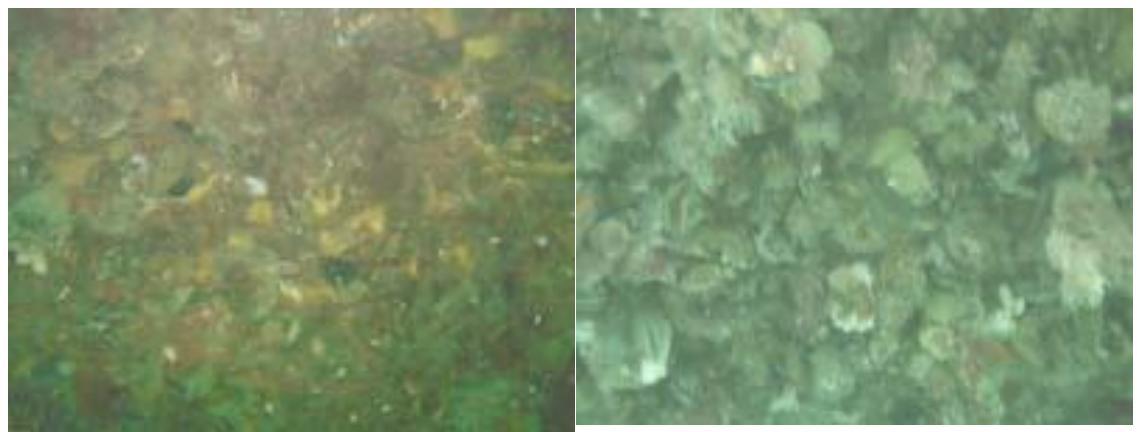
Pictures DSC00648 - 650 are taken below the 2 meter level and are of the bottom plates towards about two-thirds of the way down the vessel crossing from port to starboard. 651 shows increasing shellfish growth approaching the starboard side closer to the stern. Low light levels beneath the vessel meant no colours were observed during the dive. However, flash photographs 649 and 650 show red paint beneath the thin layer of shellfish.

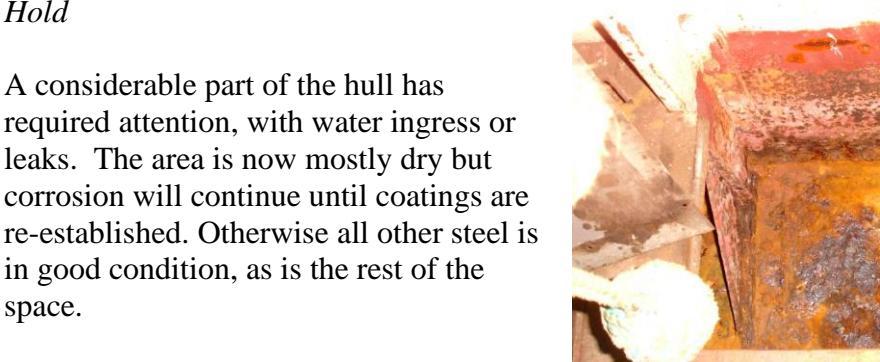
Corroded floor against water tight bulkhead.

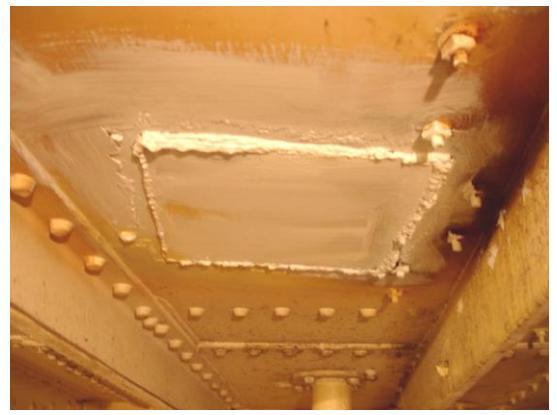
A leak in the starboard cabin has now been fixed. This area has had issues with a leaking deck and surface corrosion and there is one noticeable patch on the ceiling.

Patched portion of deck above starboard accommodation.

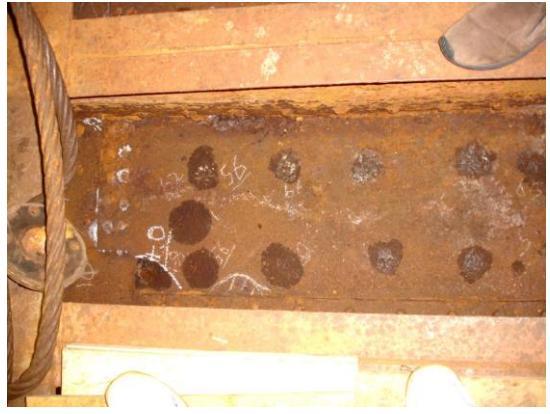
Considerable settlement of water in the bilges has left its mark not only with corrosion of the hull, but also the effects of condensation on the walls and roof of this space. The rusted bilges have been cleaned out but corrosion continues while it awaits further remedial work.

Dry but corroded hull plate with thicknesses of plate marked in chalk.

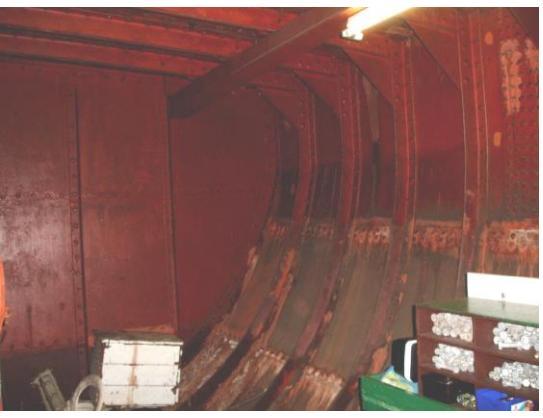
The hull was under floorboards and not greatly visible but there has been some corrosion of the hull in the bilges. The curved wall of the hull shows signs of corrosion around joints and rivets. But otherwise, it is in excellent condition.

Port side hull interior – former coal bunker.

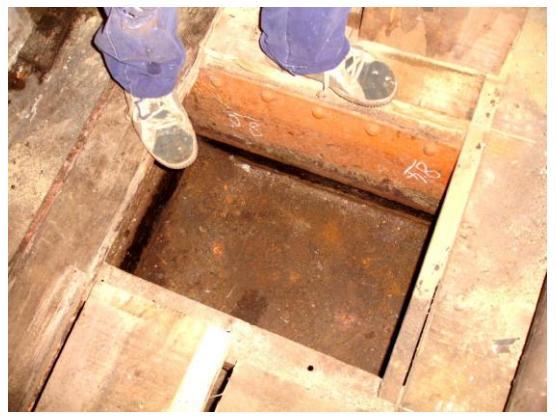
There has been some corrosion of the hull, and some superficial rust on the walls and ceiling, but otherwise it is in excellent condition.

An exposed damp hull plate.

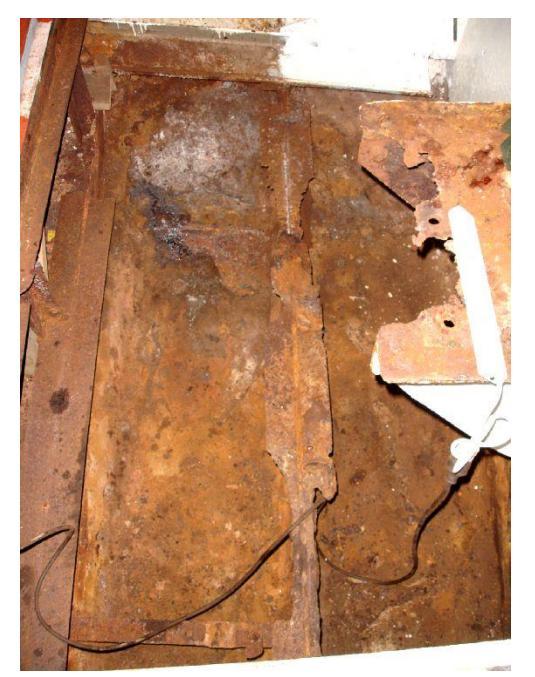
Bilge pump stand to the right, above a badly corroded part of the engine room floor.

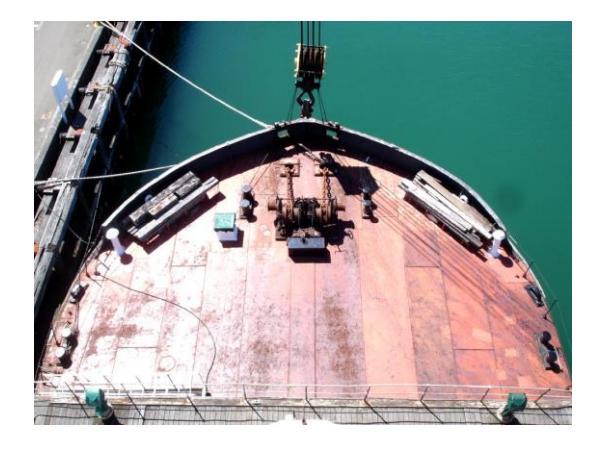
The biggest concern lies near either edge of the deck and particularly on the starboard side. This area is most exposed to the sea and corrosion here is deep seated in some places. Nevertheless there appears to be enough integrity in the remaining steel that spot repairs and treatment will suffice for a considerable period.

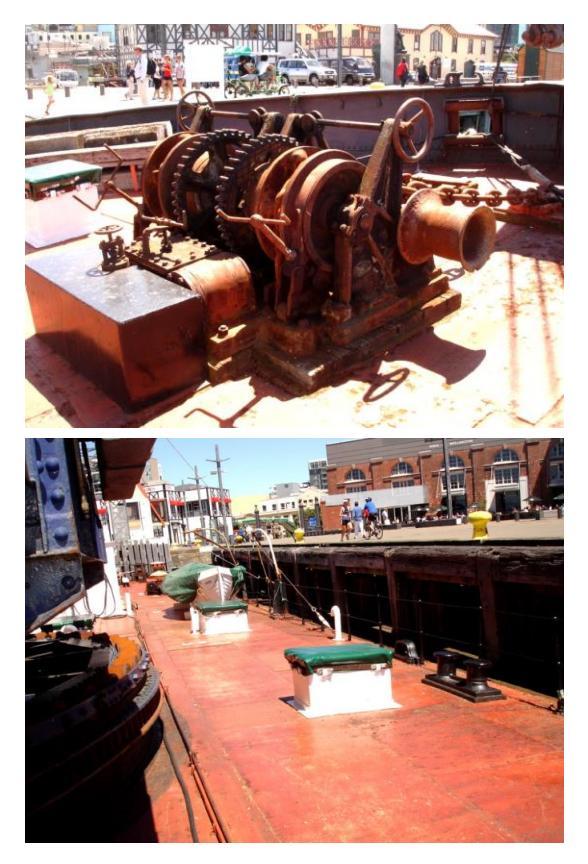
The hatches, stanchions and rails, vents, bits, scuttles and fairleads are also in good condition with the exception of the two fairleads at the stern, which are badly rusted. Considerable attention has been paid to keeping the various fixtures in good order, with regular rust removal and painting.

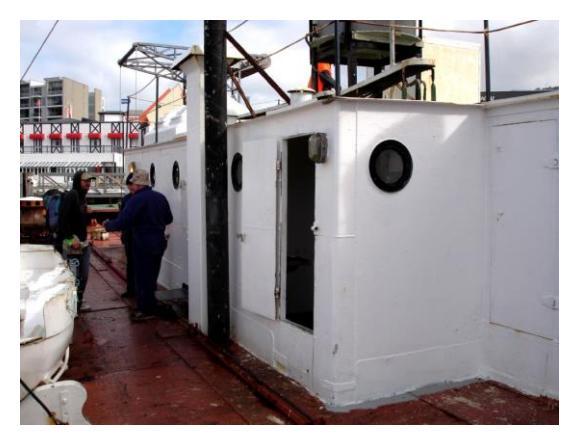
The exterior of the machine room is in poor condition. The steel cladding on the starboard side is deteriorating badly. This was itself an addition, as exposure to the elements had rotted the previous timber cladding (which matched that still on the fore and port sides.

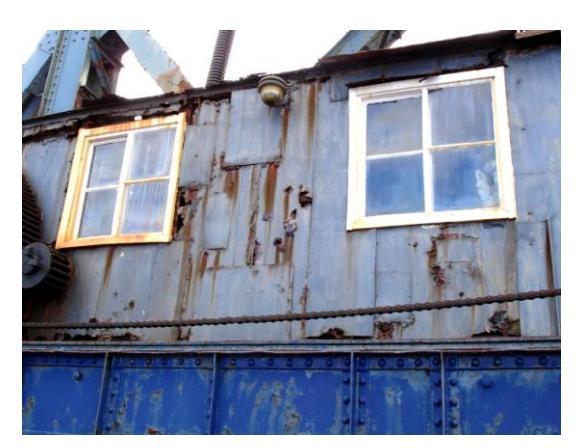
The timber walls remain intact on the fore and port sides of the room but some of these timbers are also in poor condition and will require replacing.

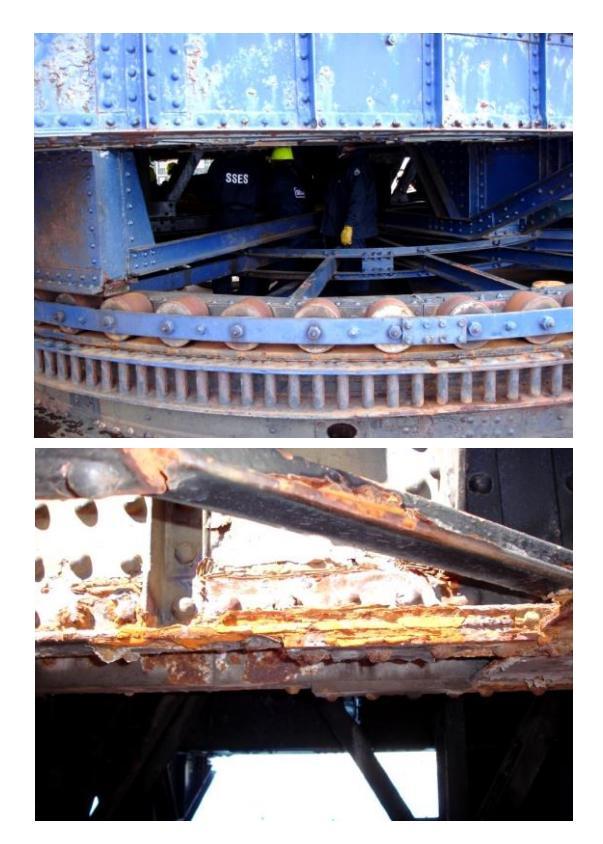
The counterweights are in fine condition, although there is some question over the condition of the steel supporting the weights to the rear. This has been passed as fit for use but will have to be revisited in 2012.

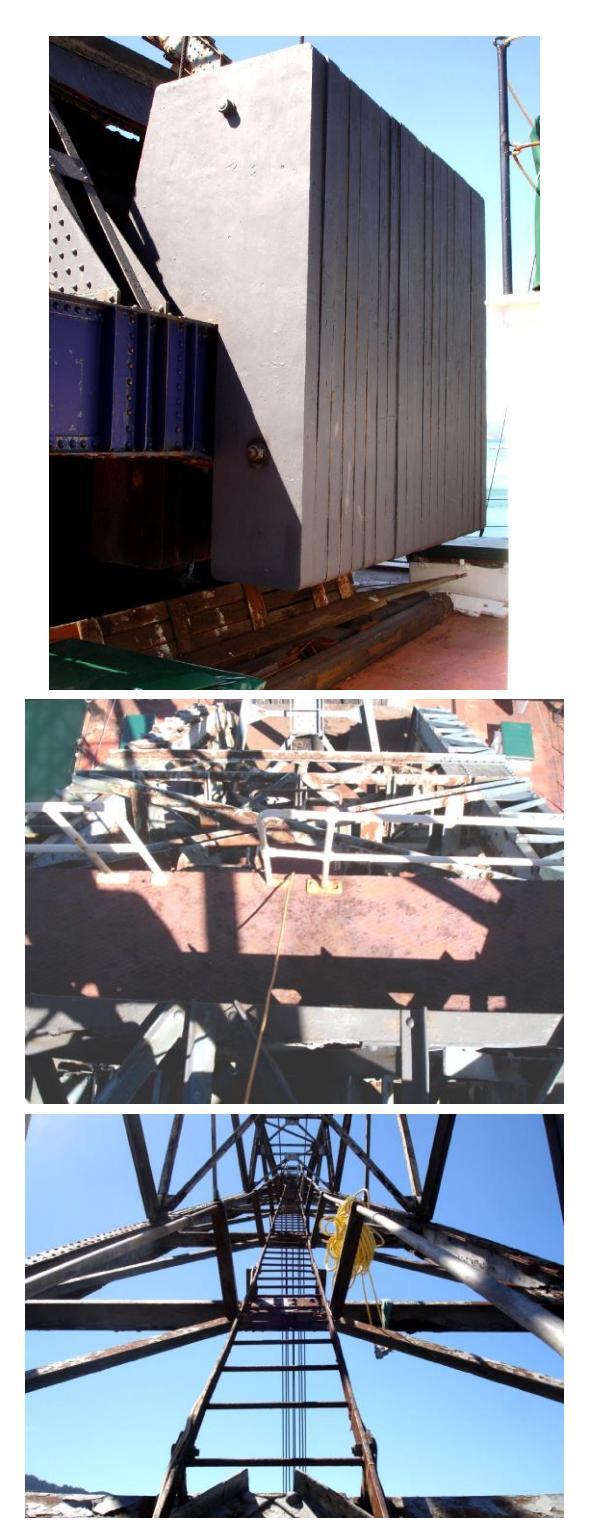
The jib, like the crane, has superficial rust over most of it. This is mostly worse than it looks but there are definitely places where the rust has weakened parts of the structure.

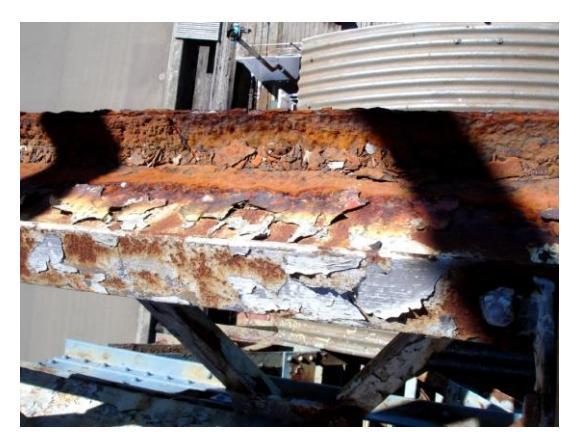
A fault in the placement of at least two of the cross beams – the tray beam is open so that it collects water – means the rusted portion will have to be cut out. Other rust will have to be treated before it becomes a bigger problem.
