Hikitia

Conservation Plan

CONSERVATION PLAN

Prepared by Michael Kelly, Heritage Consultant

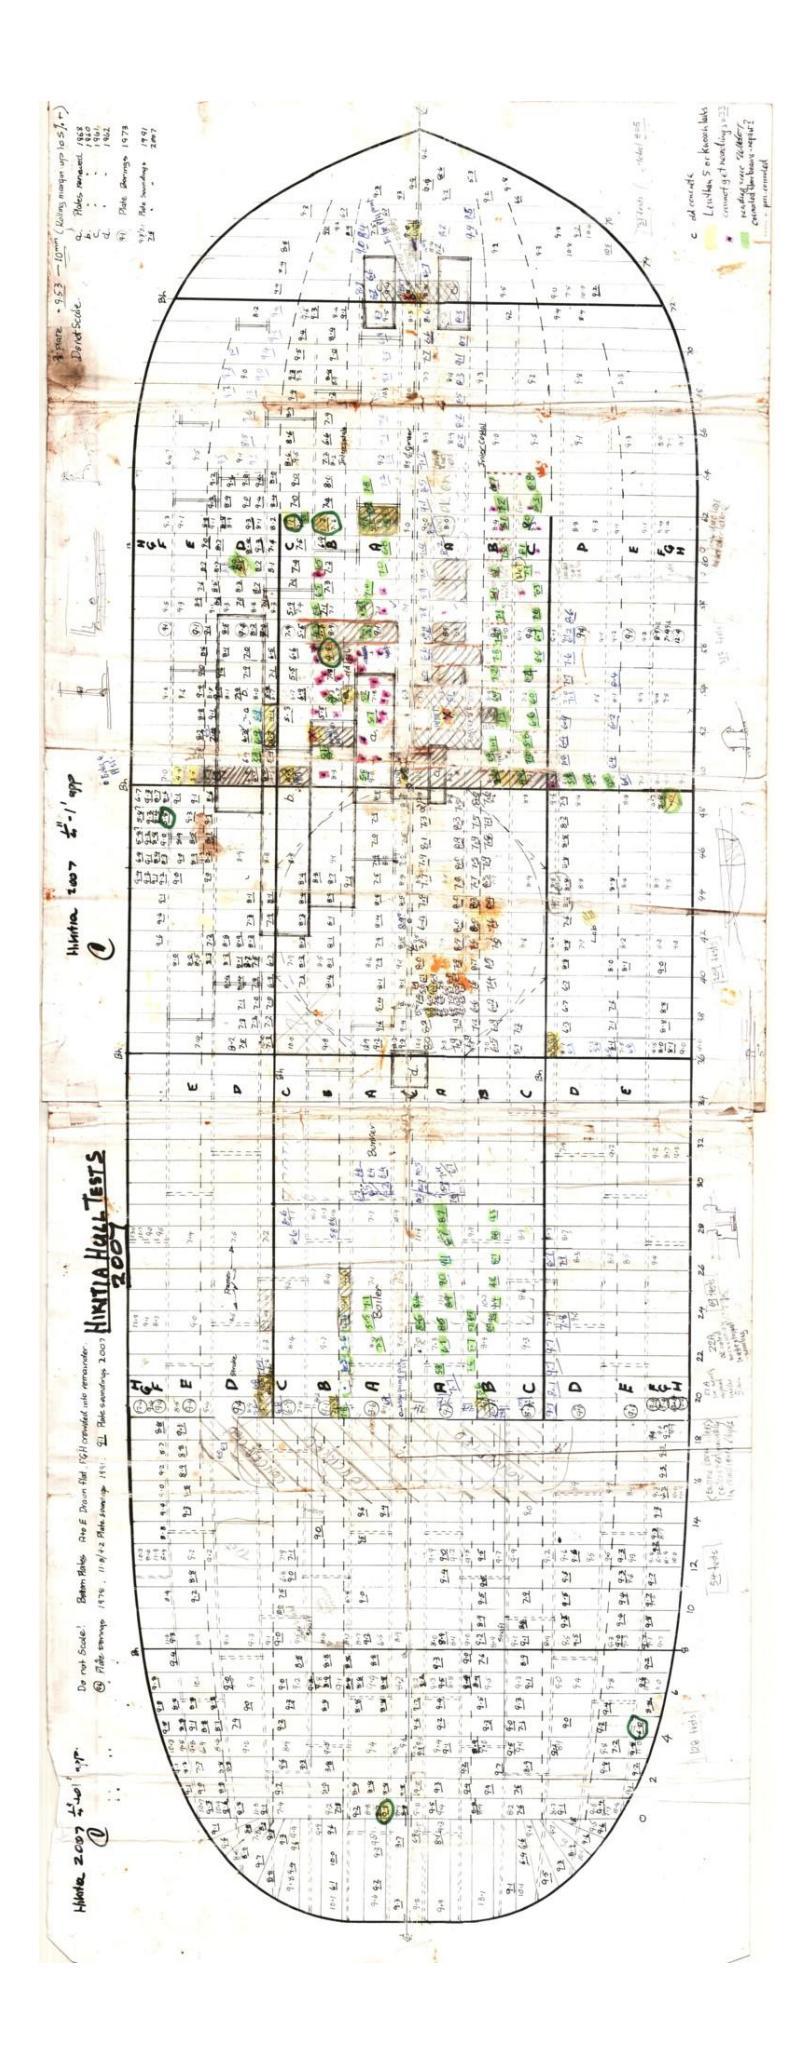
"Hikitia Hull Tests 2007" by Bruce Askew, is reproduced overleaf.

Working off a minimum hull thickness of 5mm,⁶⁶ the tests revealed that 19m² of the hull requires repairs to plating, along with 14.1m² of associated angle at the bottom of floors, intercostals and bulkheads. Repairs are needed in 34 different locations with the bulk of these being in the "Hold" area. The remainder of the hull is above the minimum of 5mm.

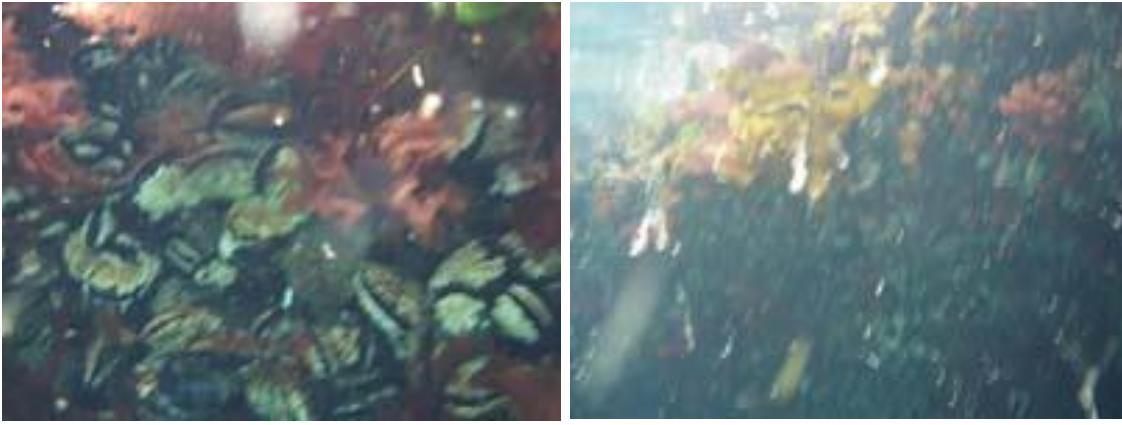
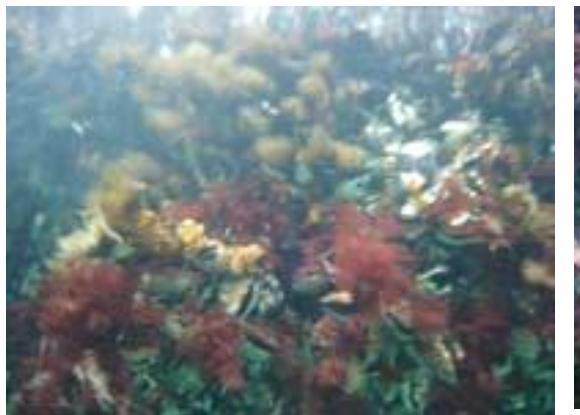
DSC00633.JPG

Pictures DSC00633, 634, 637 and 638 are taken between 1 and 2 meters below waterline on the starboard side and show the dense layer of shellfish that covers all this side to a depth of over 2 meters. Picture 638 is at the greater depth and shows a thinner layer of shellfish – about 50 - 100 mm thick - with less weed.

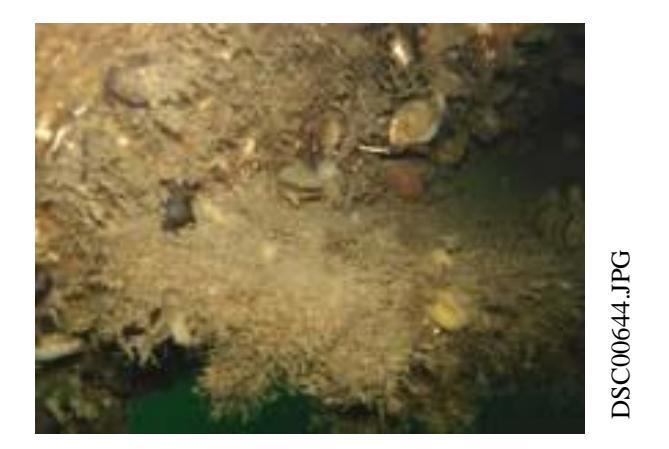
Picture DSC00644 is taken about 2.5 metres below waterline on the port side. It shows a wooden rail about 200 mm wide projecting from the side of the vessel, and which extends for about 60% of the length of the vessel. It has a very low level of growth on it, but has collected some silt from a nearby storm water outlet.

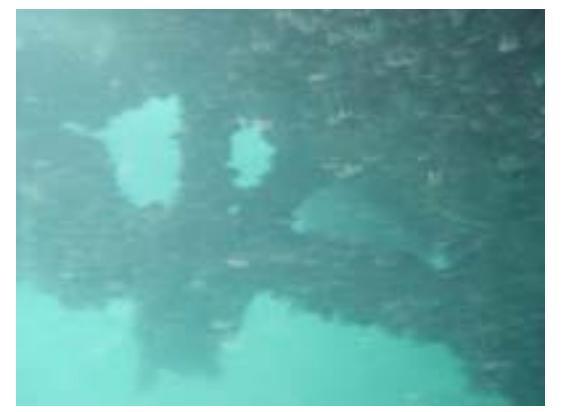
DSC00654.JPG

Pictures DSC00654 - 656 are of the starboard propeller shaft and its support brace, the upper blade of that propeller, and of the propeller support brace where it joins the hull. There is a medium level of shellfish encrustation in this relatively dim area, and little evidence of weed growth.

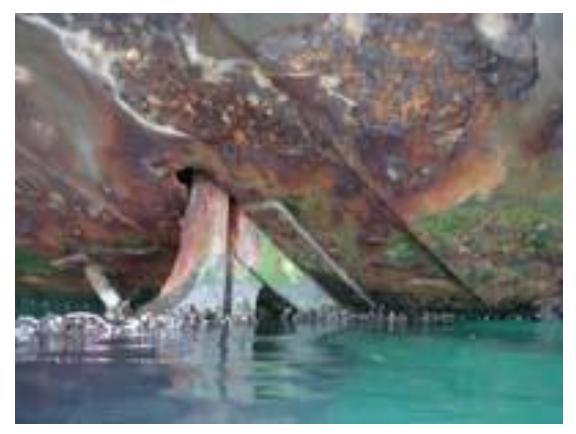
DSC00657.JPG

Pictures DSC00657 and 658 are general views of the rudder and underneath of the stern overhang. 659 and 660 are close-up views of two points of significant corrosion in the same area. They both show distinct edges of the original paint layer.

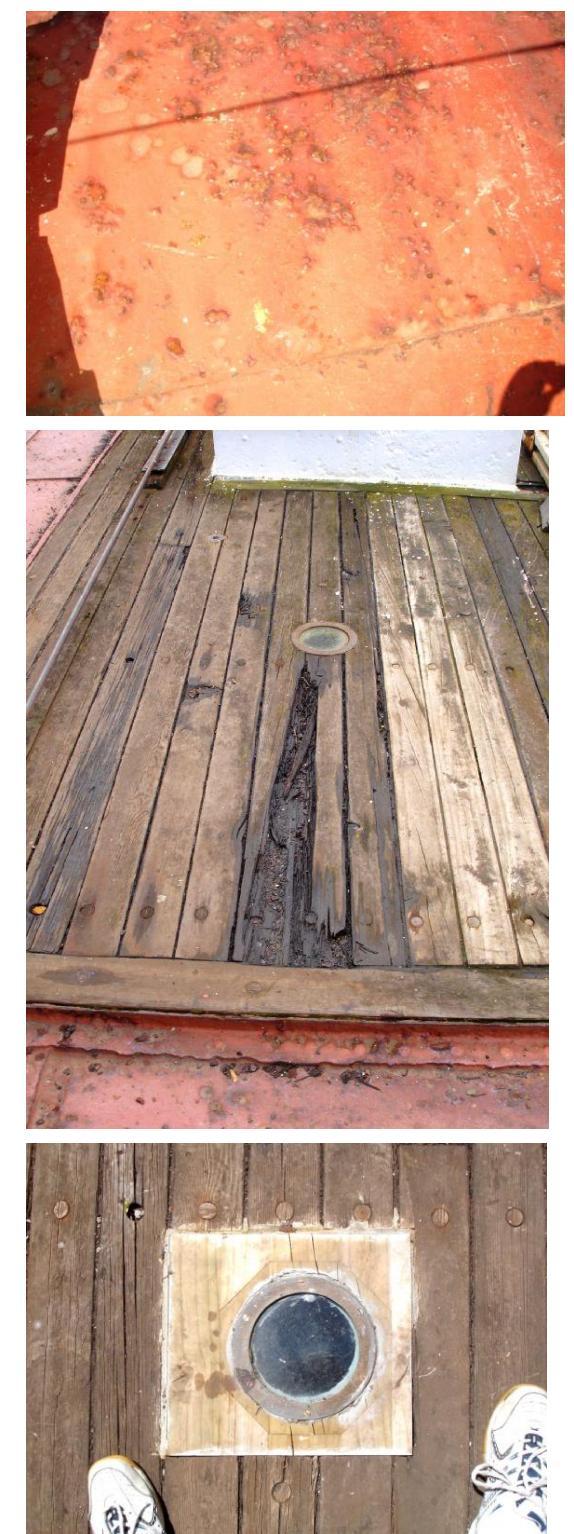
The timber decks are in relatively poor condition and will either require recaulking or replacement.

The timbers around the deck lights have already been renewed.

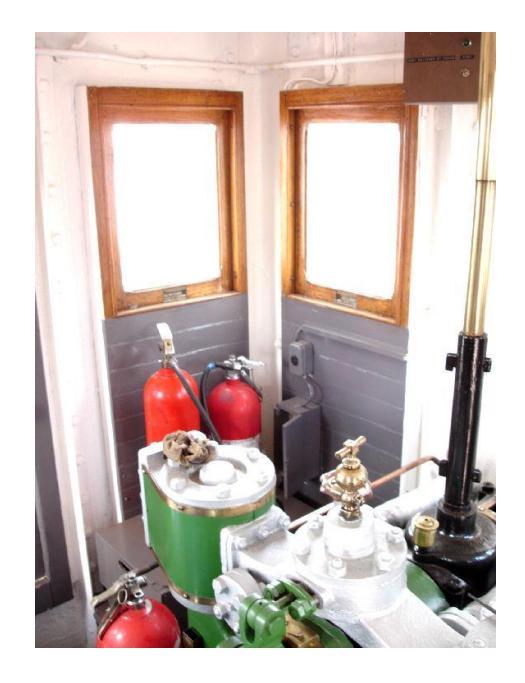
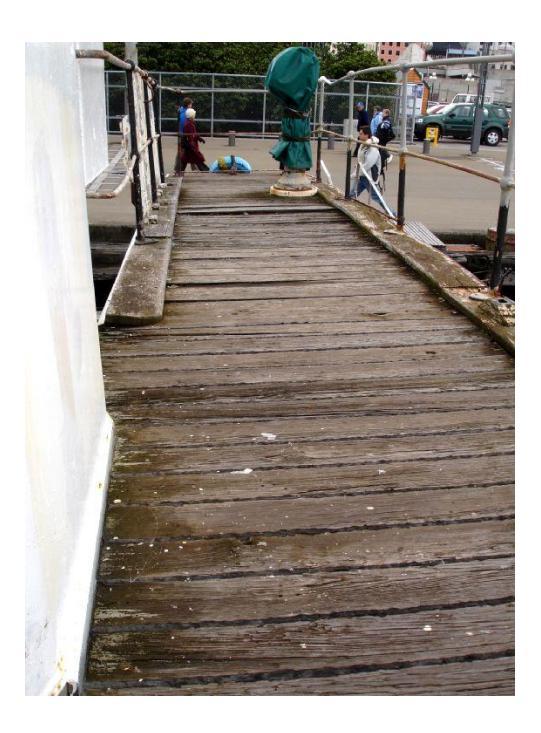
Bridge

The bridge is generally in very good order, with much recent painting and repair work bringing it up to a high standard of repair. The only obvious deterioration has been in the bridge deck, where the timbers are starting to show signs of decline.

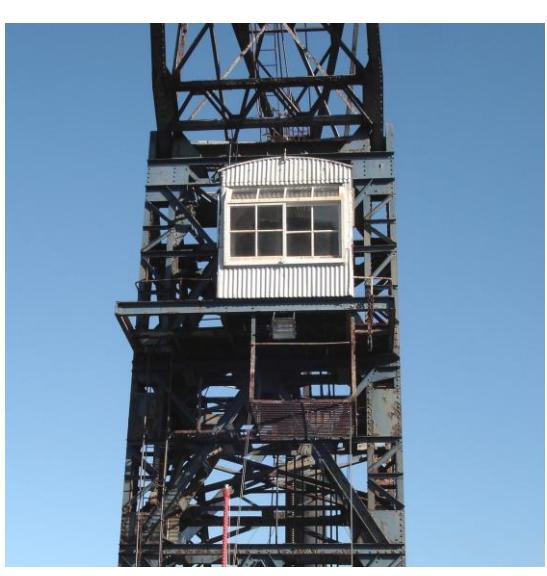
Crane superstructure, including turntable, platform, counterweights, tower, jib

The crane has corrosion in many parts, but the extent of that corrosion is the issue. Much of the rust is superficial and can partly be attributed to deferred maintenance.
